# The Saco River Corridor Commission

## Report Government Evaluation Act January 10, 2022

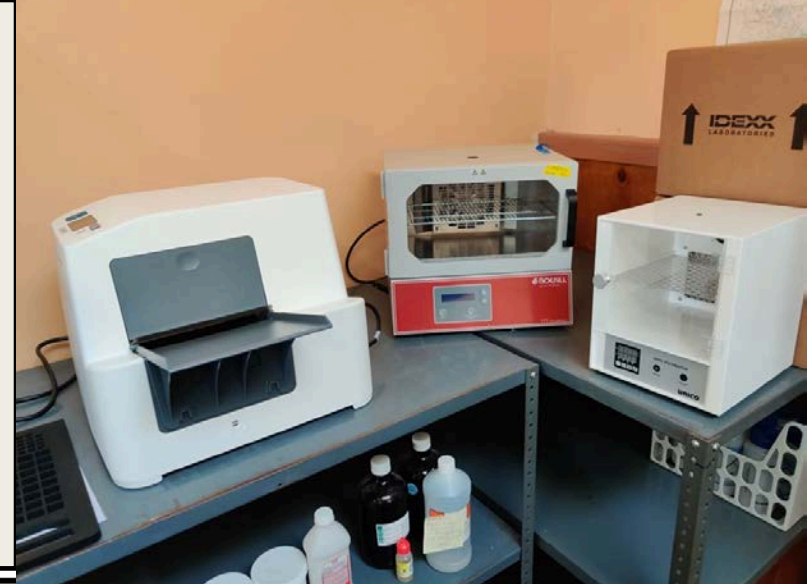
SRCC New *E. coli* Monitoring Equipment- IDEXX Colilert Tray System for “in-house” rapid response bacteria monitoring will allow the SRCC to sample for *E. coli* at almost all Corridor sample sites, tributary streams to the Saco, Ossipee, or Little Ossipee Rivers, or other waterbodies within the Corridor. This equipment will allow the SRCC autonomy over our sample results, leading to faster rapid response sampling when *E. coli* or Enterococcus exceed safe levels. Results are obtained within 24 hours.

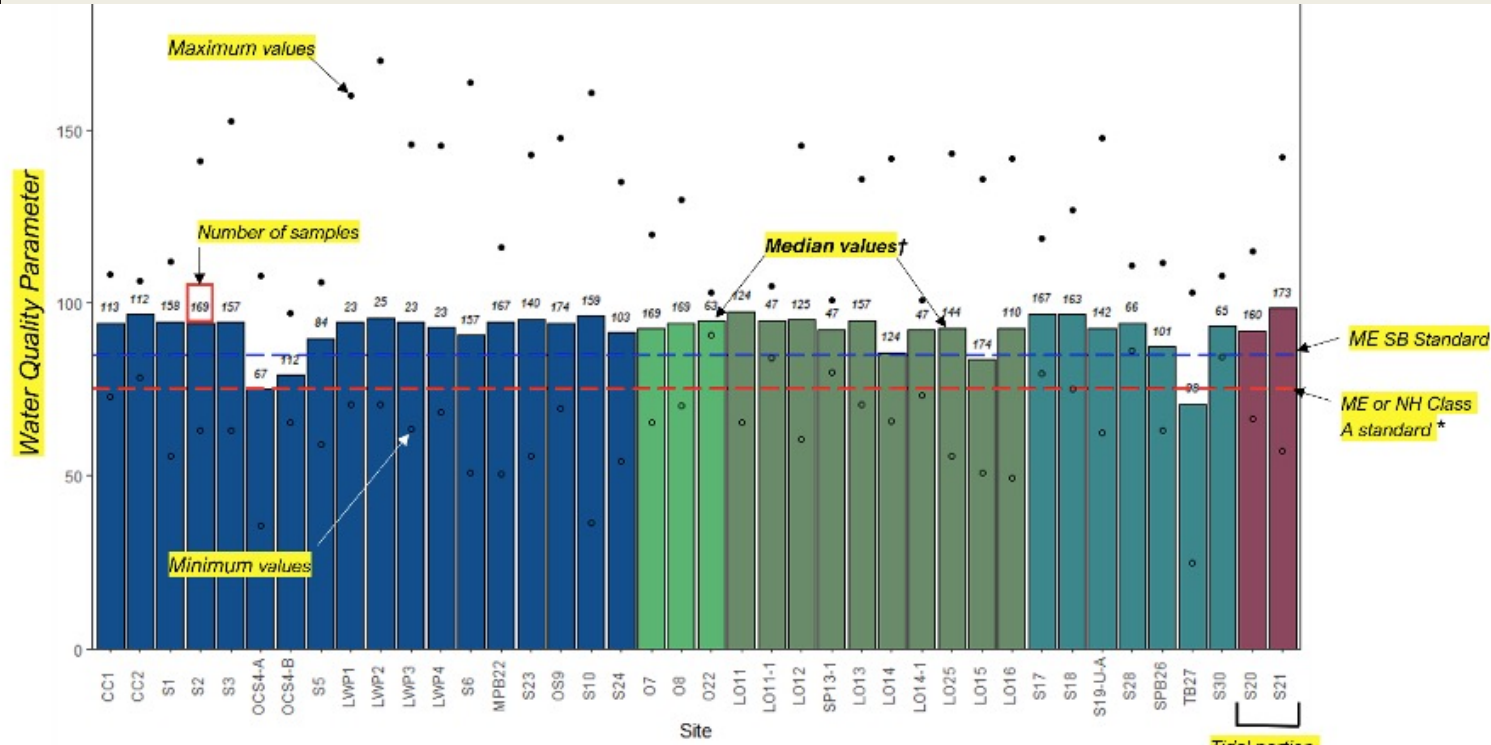
**Figure 8.** Example figure to guide interpretation of water quality summary figures for parameters.

†The bars in the *E. coli* graph represent geometric mean values.

\*The dashed red line represents ME Class A standards, if applicable. If not, NH Class A standard is used. If neither exist, then natural background/minimal disturbance levels are used.
